CITY OF MIAMI BEACH
Office of the City Manager
Letter to Commission No. 194-2005

Subject: **DISCUSSION REGARDING CASTLE BEACH HOTEL/CONDOMINIUM**

CASTLE BEACH CLUB
5445 COLLINS AVENUE
MIAMI BEACH, FLORIDA

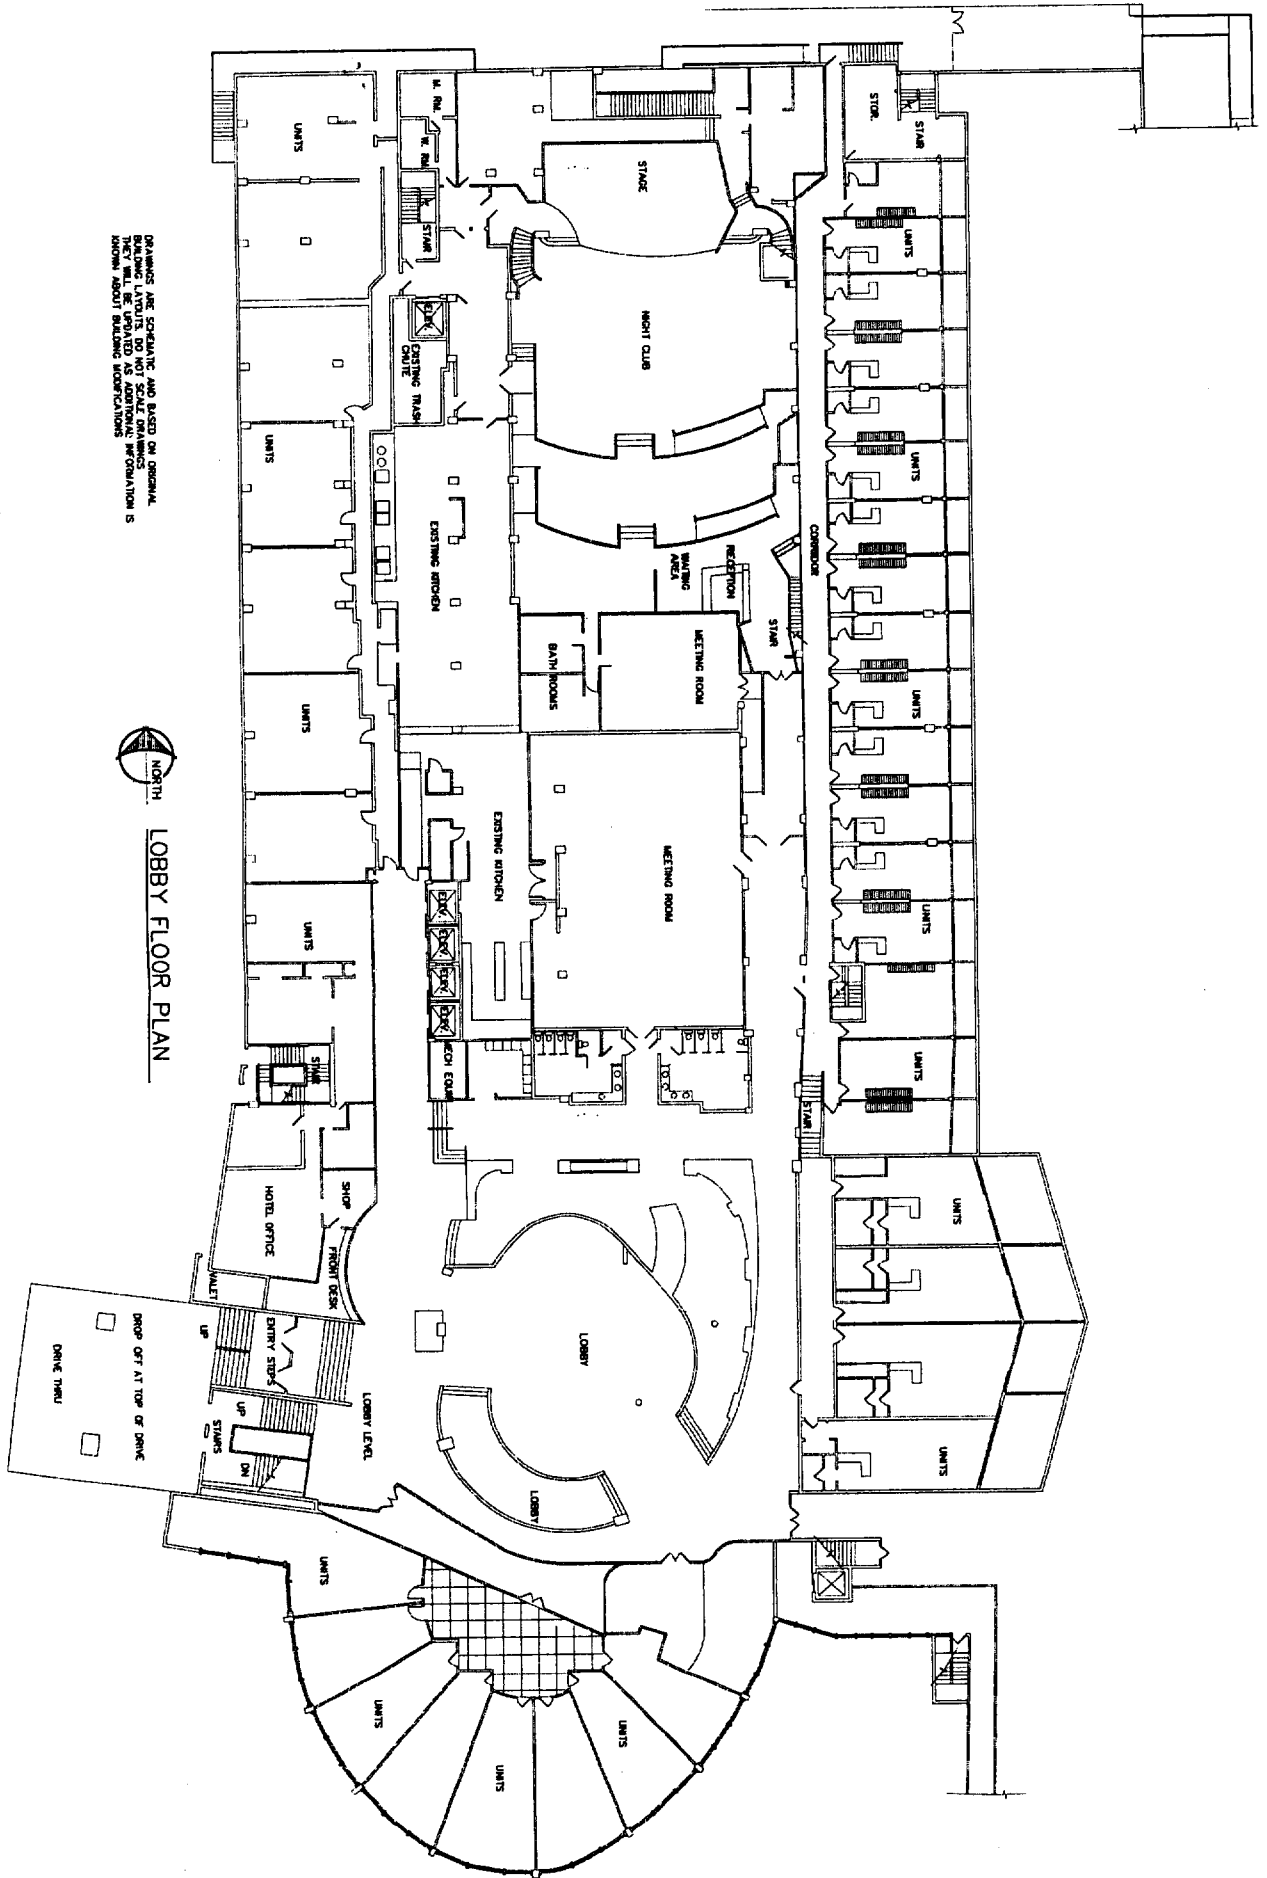
LOBBY FLOOR PLAN

DRAWINGS ARE SCHEMATIC AND BASED ON ORIGINAL
BUILDING LAYOUTS. DO NOT SCALE DRAWINGS.
THEY WILL BE UPDATED AS ADDITIONAL INFORMATION IS
KNOWN ABOUT BUILDING MODIFICATIONS
